TechTalk 87
DATV Testing Report
- Part 4 (Field Testing)
 by **Ken Konechy W6HHC**
 &
Robbie Robinson KB6CJZ

This is the fourth OCARC TechTalk article describing the testing of the Digital-ATV station that we had planned.

This month we report on the results we obtained in field testing of a Digital-ATV portable unit in the City of Orange, here in Southern California.

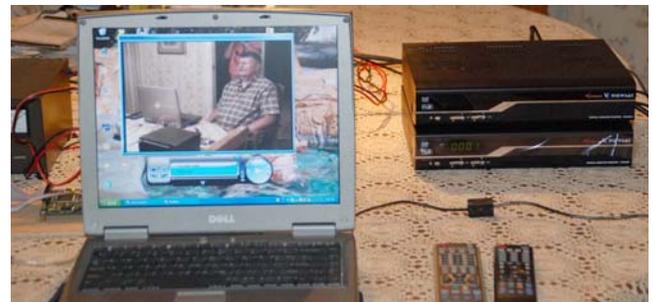
Figure 2 – Bench testing the ViewSat STB for OPD

Another ViewSat VS2000 DVB-S STB was purchased on eBay for installation inside the EOC Radio Room for the purpose of conducting these DATV field Tests. The eBay cost of this FTA STB unit was less than \$60 including shipping. Fig 2 shows the new STB (bottom unit) being tested side-by-side to Ken W6HHC personal STB receiver before the field tests began.

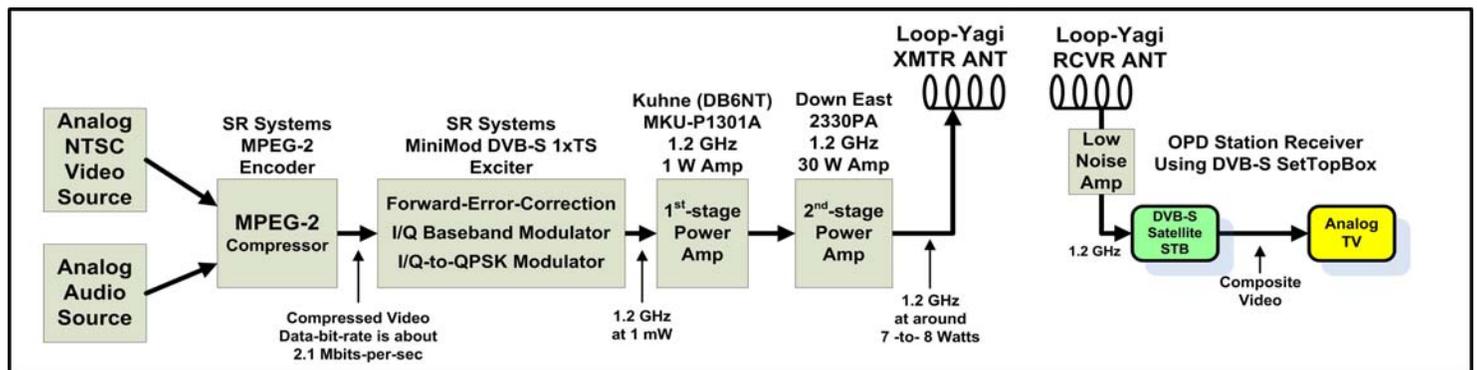
Figure 1 – Block Diagram of DVB-S Transmitter and Receiver for DATV Field Tests

Fig 1 is a block diagram of the set-up used during the recently completed field tests of DATV. The transmitter, and power amplifiers and SetTopBox (STB) receiver have all been described in more detail in the early TechTalk testing reports.

The frequency used for the field tests was 1.292 GHz. Ken W6HHC had planned to set up the test frequency on 1.2915 GHz, but discovered that the STB menu would NOT allow him to enter 0.5 MHz digits. The Symbol-Rate was set to 2.2 MS/sec...producing an DVB-S RF BWallocated of 3 MHz. The Forward Error Correction (FEC) was configured to 1/2.

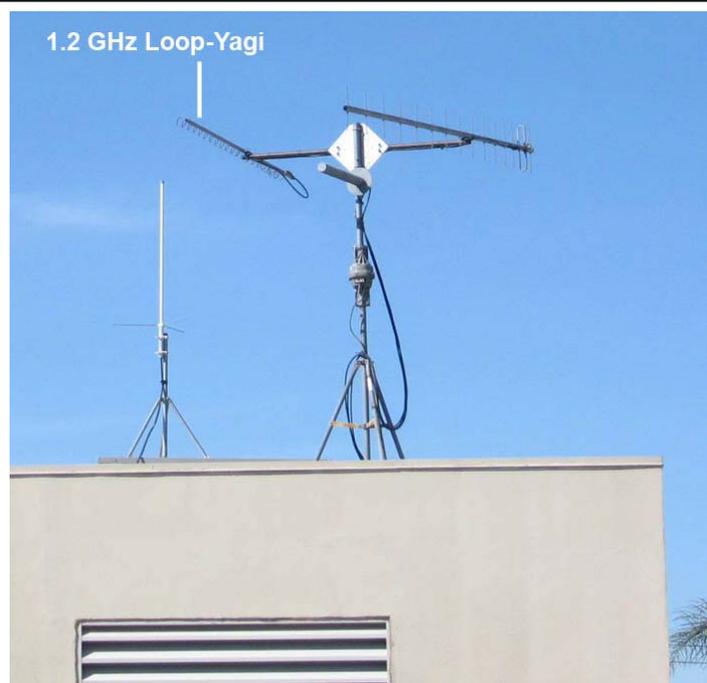
Figure 3 – 1.2 GHz Loop-Yagi on roof of OPD

The receiving 1.2 GHz antenna (Fig 3) was a 24-element loop-Yagi antenna mounted 3-stories high on top of the Orange PD building. The loop-Yagi antenna is made by Directive Systems (in Maine US). A Down East Microwave LNA for 1.2 GHz was installed for the field tests to drive the received DATV signal down 250+ feet of coax to the EOC Radio Room receiver.

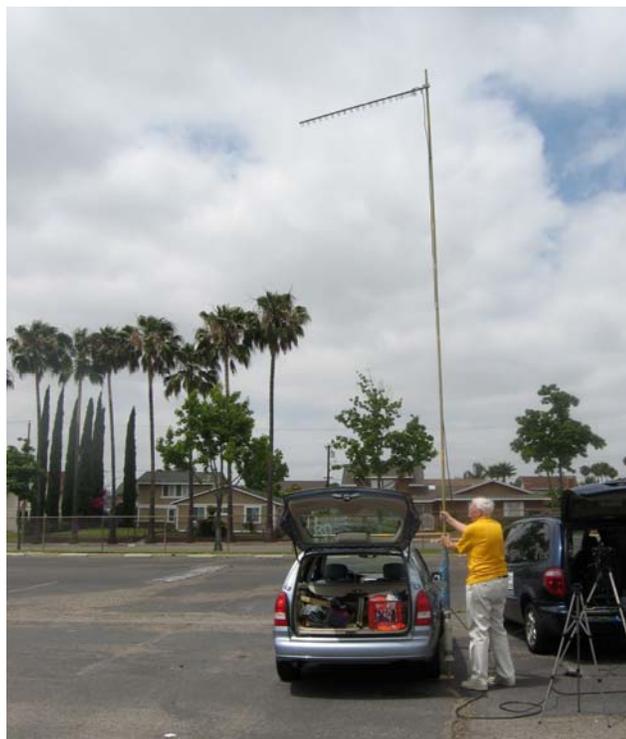
Figure 4 – Bruce KC6DLA adjusts direction for the Field set-up of the 1.2 GHz Loop-Yagi

The field transmitting antenna is also a 24-ele loop-Yagi from Directive Systems that Robbie KB6CJZ keeps in his closet of spare antennas. **Fig 4** shows a typical set up of the portable antenna during the field tests. The loop-Yagi is mounted on 25-feet of Radio Shack stacking masts.

COAR member, Bruce KC6DLA, provided the field masts and a clever mast-support system that mounts to the roof-rack of a station wagon or mini-van....see the mast support details in **Fig 5** and **Fig 6**.

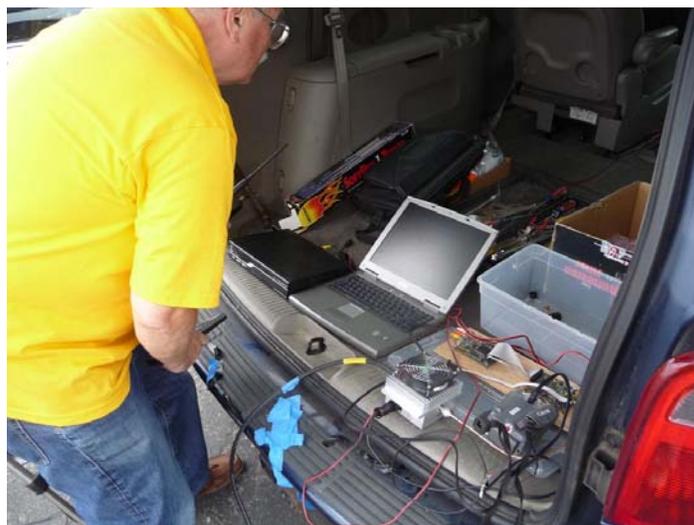
Figure 7 – Field DATV transmitting station in back of MiniVan (sniffer receiver display in center)

While Robbie KB6CJZ and Steve KI6DDE manned the OPD receiving station, Ken W6HHC set up the DATV transmitting station in the back of his mini-van...see **Fig 7**. Just to be prepared, Ken also set up a STB receiver with a “sniffer” antenna and a notebook computer display to confirm that a video picture was actually being transmitted...if there was a lack of picture at the OPD. You can see the Notebook display in the center of the **Fig 7**.

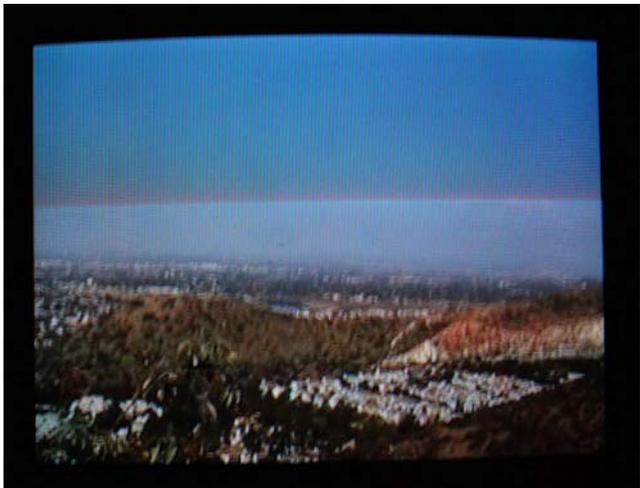
Figure 8 – First received DATV Video at OPD

Steve KI6DDE reported seeing a picture at the Police station from El Modena High School, even before Ken could finish setting up his "sniffer" receiver. The picture was perfect! Robbie KB6CJZ reported that the QUALITY monitor on the STB menu displayed 100%.

Fig 8 and **Fig 9** show the quality of the DATV signal that was received in the EOC Radio Room.

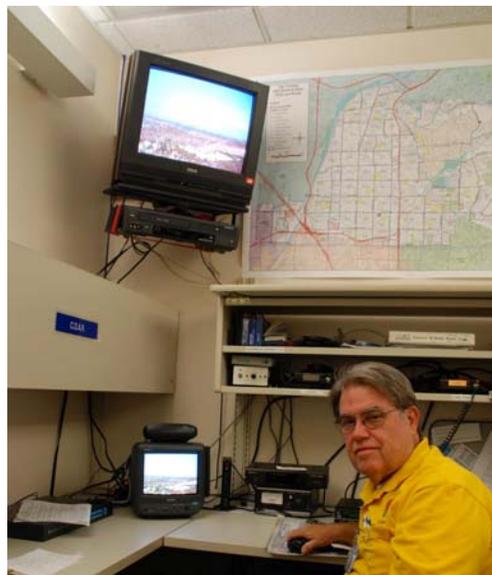
Figure 11 – Robbie KB6CJZ views received DATV Video inside EOC Radio Room

A picture was reported at the EOC Radio Room as soon as the transmitter switch was turned on. Again Robbie reported the DATV picture was perfect and the SetTopBox QUALITY meter read 100%.

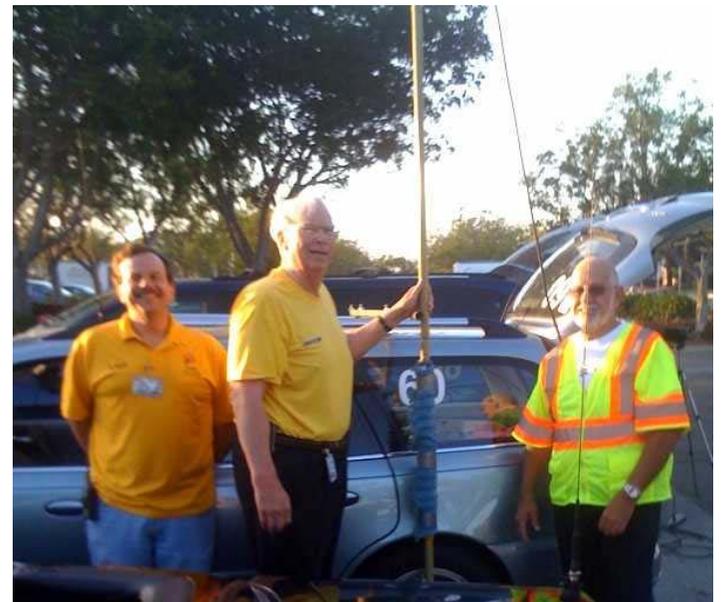
Fig 15 – At DATV Field Site during Drill are (L-R): COAR Members Dave KG6RWU, Bruce KC6DLA, and OPD Volunteer Dan Claypool (Antenna is aimed straight into two trees on left)

The second DATV test site we chose, the parking lot of the AMTRAK train station, was picked for two reasons. First, COAR RACES had also tried analog-ATV tests on 440 MHz from this location two years earlier with extremely poor video quality...just P1. Second, COAR had been asked to test DATV at an upcoming RACES drill for the city. We knew that we would be asked once again to supply video from the AMTRAK station during the RACES drill. The test distance is only 1.8 miles, but includes, 2-story commercial buildings, 3-story University buildings, homes, and plenty of trees. We had to aim the 1.2 GHz antenna right into a pair of large leafy trees, about 75 feet away.

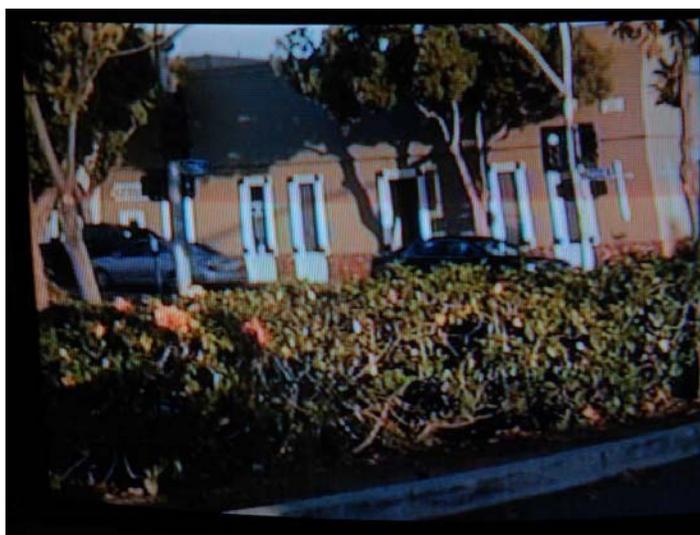
Figure 14 – Live video as received in EOC Radio Room during the RACES Drill (analog TV display)

Fig 14 shows the quality of the received video as seen on an analog CRT TV display. **Fig 17** shows the crisp clarity and quality of the DATV video distributed onto a large-screen digital display. Robbie KB6CJZ has commented that sweep-speeds and camera shutter speeds prevent these JPEG photos from really capturing the great quality he was actually seeing with his eyes on the CRT TV display.

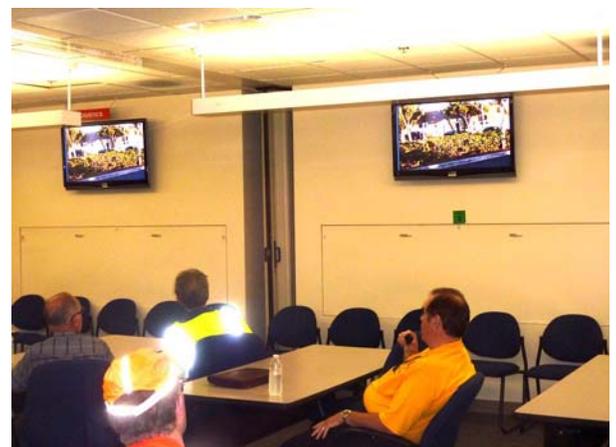
Figure 16 – Live video as received in EOC RACES Drill is distributed to large-screen displays

The received DATV signal was first displayed in the EOC Radio Room. The video was then distributed to large-screen LCD many displays inside the EOC room itself, as shown in **Fig 16**.
