Heathkit of the Month - Extra #1:  
by Bob Eckweiler, AF6C

**MAINTENANCE**  
**Slide Switch Repair**  
**Featuring the HM-102**  
**HF Power Meter**

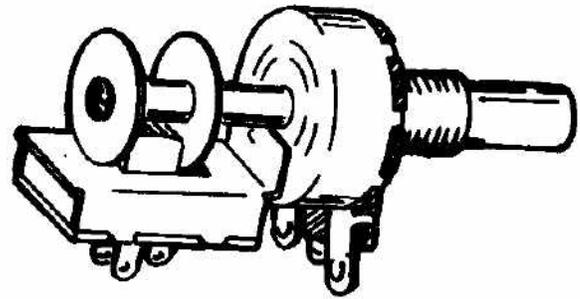
Figure 1: Pot with Integral Slide Switch

Finding a replacement for this pot - switch assembly (Fig. 1) would not be easy. The alternative was to take it apart and see what ailed it. The switch assembly does not come separate from the pot, but the fiber switch back plate can be removed by lifting the four metal tabs that hold it in place. This is not easy to do.

With some trepidation I was able to bend the tabs up carefully and totally disassemble the switch. Once the tabs were lifted it was obvious there was at least one spring underneath so extra care was taken not to have pieces shoot everywhere. The switch was then cleaned, lubricated and reassembled. The contact surfaces on this switch were badly tarnished and almost black, but they cleaned up to shiny silver with a cotton swab and some 91% alcohol. When I was

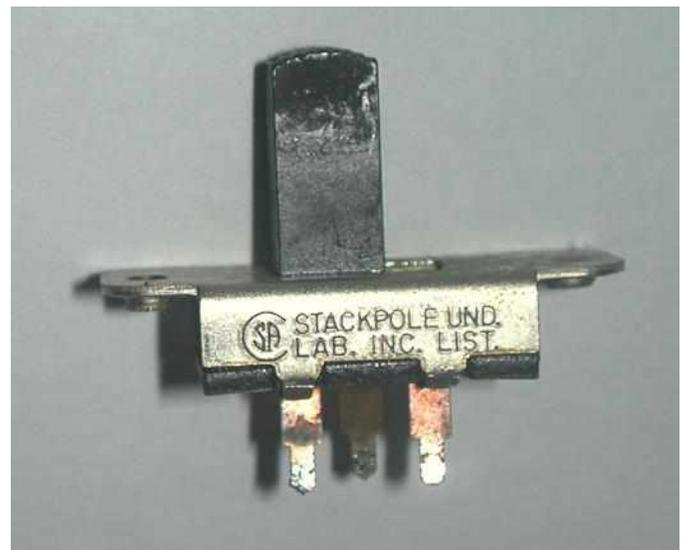
Figure 2: Slide Switch from Circuit Board

After reassembly, I tested the HM-102 performance and the SWR section worked as solid as I could ever wish for. Unfortunately, though, the Power calibration still remained erratic. That circuit used a second slide switch. This one was a different style designed for circuit board mounting and included a vertically extended slider; however the guts of the switch appeared identical (Figure 2).

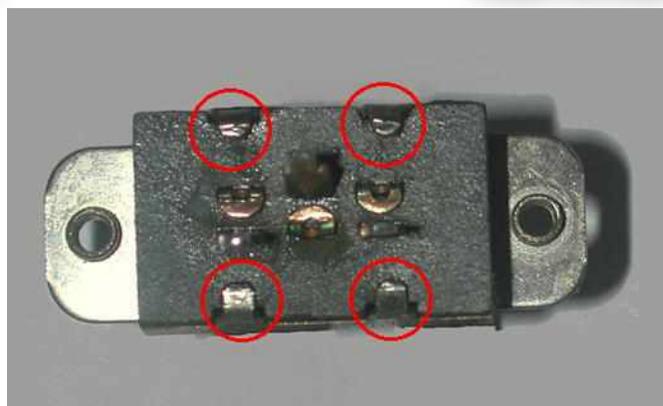
If you examine the slide switch you will see four tabs that are bent over holding the fiber plate with the terminals to the metal switch bracket (See Figure 3). These need to be carefully bent up. Caution, excessive bending will cause the tabs to fatigue and break. Without

**Figure 3: Slide Switch Showing the Tabs**

damaging the metal frame or fiber plate you will need to get something under the tab and lift it slightly. I've never had luck using needle nose pliers, but an old pair of wire cutters can be used to get under the tab. You don't want to mar the metal frame so it is wise to protect the other cutter blade; I used a thin piece of brass shim stock. Again just bend the tab up far enough so you can use needle nose pliers to complete the bending. Keep pressure on the fiber plate so it doesn't come off and allow the spring and contact to fly off.

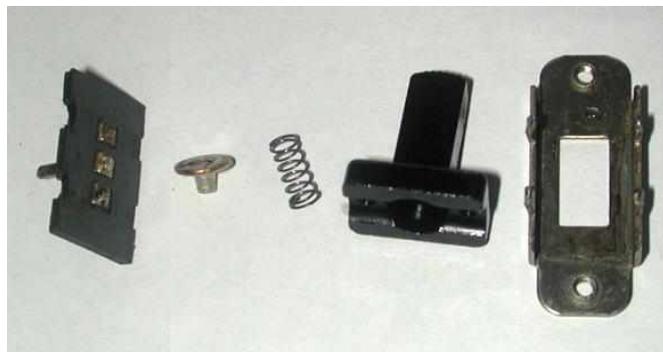
Now gently remove the fiber plate, contact and spring. Also remove the plastic slider. When you are done you should have five parts as listed in figure 4.

**Figure 4: Disassembled Slide Switch parts. Left to right: Fiber plate with terminals and fixed contacts, disc contact, spring, plastic slider and metal switch frame.**

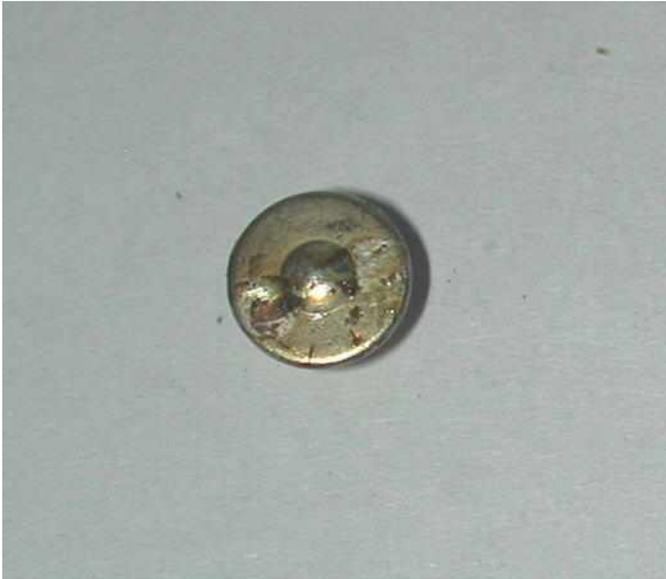
**Figure 5: The silver disc contact prior to cleaning. The earlier switch contact was much dirtier to the point of being covered with black tarnish. However this had enough dirt to cause switch failure.**

Clean the disc contact (figure 5) with the alcohol. It should clean easily to a silver shine - this

part is silver plated so don't use anything abrasive. If your disc shows signs of burning, polish it gently; the HM-102 puts minimal current through the slide switches so this is not a problem. That may not be true for switches in other Heathkits. Similarly, clean the contacts on the fiber board. These too should clean up to a silvery shine.

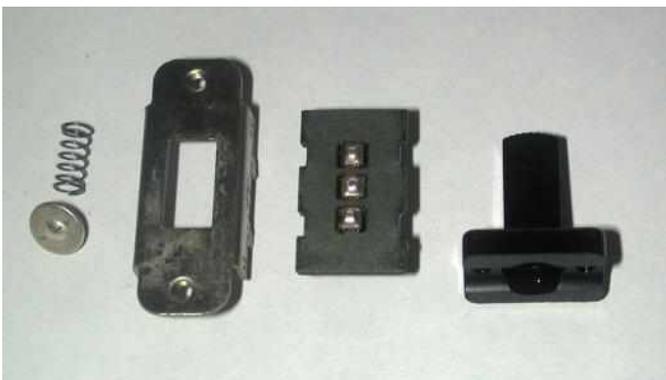
**Figure 6: Cleaned Parts: Ready for lubrication and assembly.**

The spring in both the switches was clean; I left them alone. However, I did clean all the lubricant off the metal switch frame, again with the alcohol. The plastic slider was washed with de-

tergent and water at the sink, and everything was set aside to dry (Figure 6)

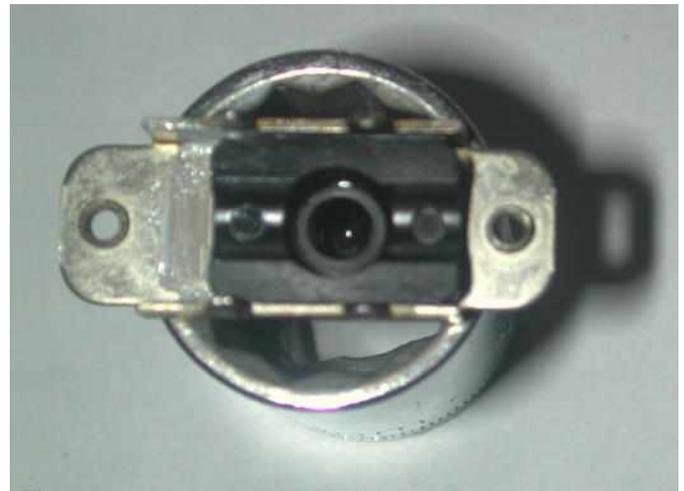
**Figure 7: Frame with slide inserted**

Use something that will hold the metal frame above the table; I used a 19 mm socket wrench. Place the metal frame atop the socket with the tabs pointed up. Apply a small film of lithium grease to the frame's channel where the plastic slide moves back and forth using a cotton swab. Place the plastic slide in the frame (it can go either way) and slide it back and forth a few times to disperse the grease; then gently wipe away any excess grease. (figure 7).

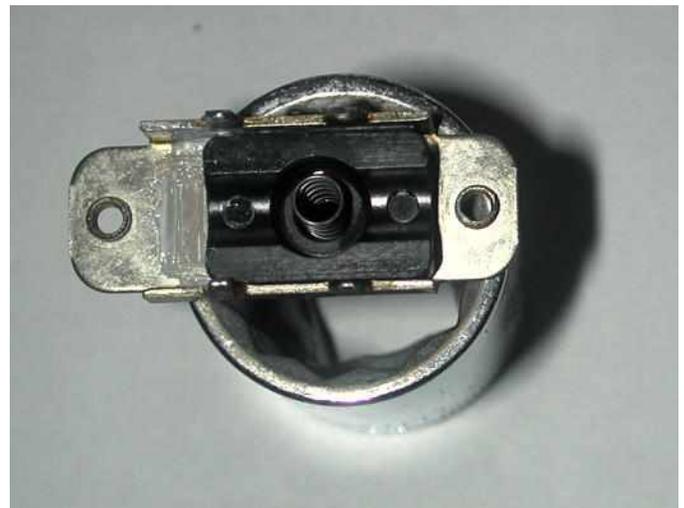
**Figure 8: Slide with spring inserted**

Insert the spring into the well in the plastic slider (figure 8) and gently place the contact

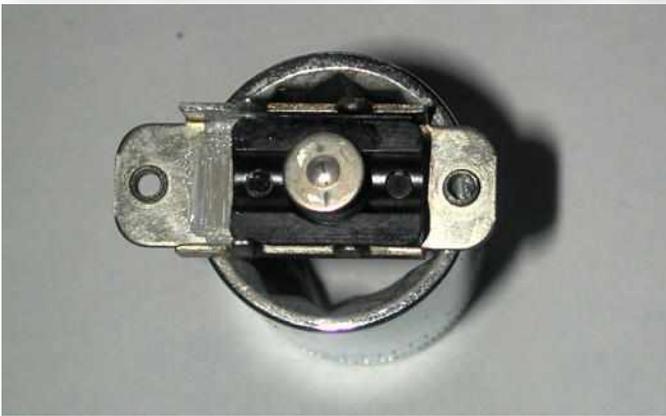
**Figure 9: Slide with spring and disc contact inserted**

disk onto the end of the spring (figure 9). Try not to touch the contact surface, and clean with some alcohol and a cotton swap if you do.

Now, place a tiny drop of De-Ox-Id or other quality contact lubricant\* on the contact disk. Spread the contact cleaner evenly on the surface; I used a thin strip of plain white paper. Rotate the disc contact so that the previous wear, if noticeable, is off from the axis of slide motion. This can be seen in figure 9 with the previous wear marks now almost vertical.
